TVA's Measurements taken in the main channel  
Just upstream of the Melton Hill Dam

TVA's Melton Hill Reservoir Water Quality at Clinch River Mile 24 - July 28, 2008

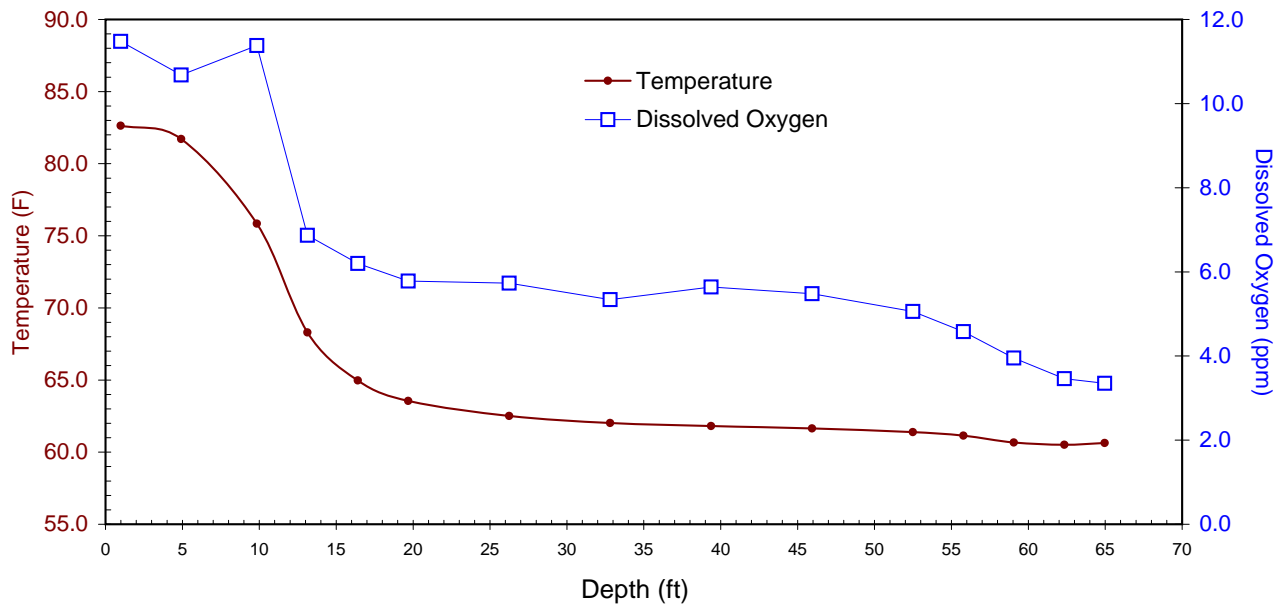
Depth (m)	Temp (C)	Cond	PH	DO	RM	Secchi (m)	Time	Date	Reservoir	Depth (ft)	Temp (F)	DO
0.3	28.1	270	8.8	11.5	C24	na	1000	07/28/08	Melton Hill	1	82.6	11.5
1.5	27.6	271	8.7	10.7						5	81.7	10.7
3	24.4	300	8.4	11.4						10	75.8	11.4
4	20.2	321	7.6	6.9						13	68.3	6.9
5	18.3	325	7.5	6.2						16	65.0	6.2
6	17.5	326	7.5	5.8						20	63.6	5.8
8	17.0	326	7.5	5.7						26	62.5	5.7
10	16.7	327	7.4	5.3						33	62.0	5.3
12	16.6	327	7.4	5.6						39	61.8	5.6
14	16.5	326	7.4	5.5						46	61.6	5.5
16	16.3	327	7.3	5.1						52	61.4	5.1
17	16.2	327	7.3	4.6						56	61.1	4.6
18	15.9	327	7.2	4.0						59	60.7	4.0
19	15.8	328	7.2	3.5						62	60.5	3.5
19.8	15.9	328	7.2	3.4						65	60.6	3.4
